SPARK PLUG INSTALLATION TIPS

TECHNICAL INFORMATION SHEET

SPARK PLUG OVERTIGHTENING

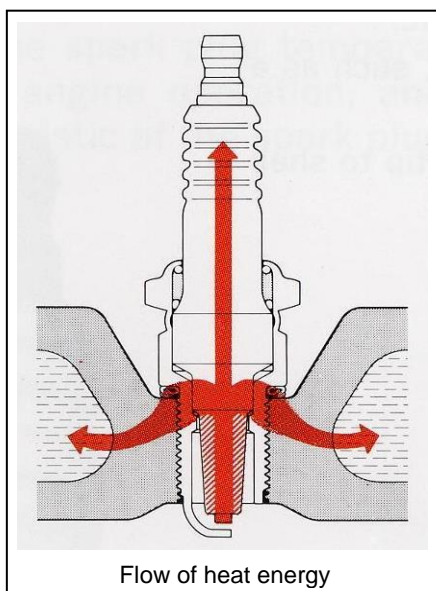
If too low a torque is applied to a plug insufficient heat transfer can occur and the more likely that overheating can result.

Damage to the firing end of a spark plug can result from this reduced heat dissipation – which can cause hot spots, engine knock/pre-ignition/detonation to occur. Similar damage can occur to a plug that becomes loose and vibrates in the cylinder head.

- *It is important, therefore, that particular attention is paid to installation and tightening information when fitting spark plugs into an engine. This is generally available within most vehicle manufacturers own service information data, workshop repair manuals, in all our catalogues and on most packaging boxes in which NGK spark plugs are supplied.*

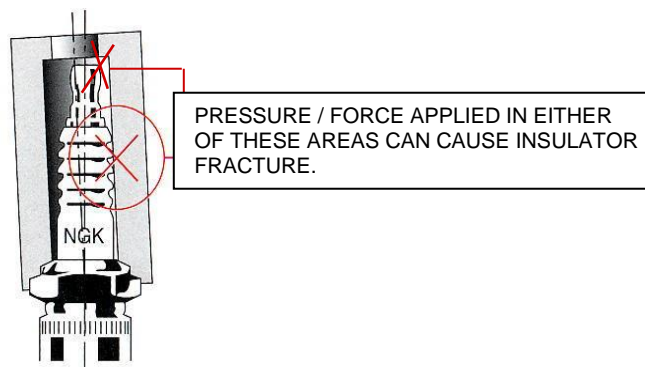
If the wrench slips off or tilts at an angle on the spark plug hexagon, a crack in the insulator can occur.

A poorly fitted or a poorly designed spark plug socket causes this problem. The diagrams below show how wrench slip occurs and how pressure can cause breakages.

Poor socket design

Preferred socket design

Solution: select a hexagonal type socket design that is the least likely to slip, still ensuring that the socket does not tilt on the spark plug hexagon during tightening or loosening. If an extension bar is required for deeply recessed spark plugs, select one that is as short as possible.

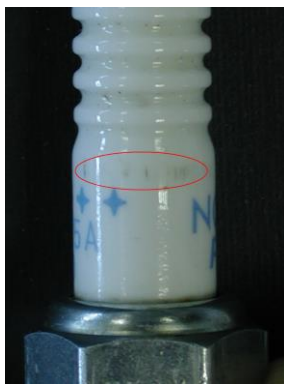
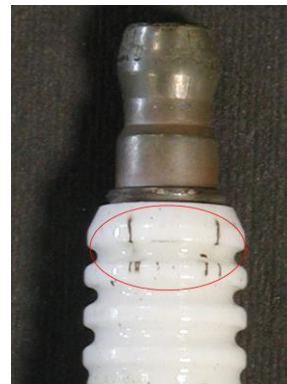
Flashover is the result of the HT voltage taking an easier path to earth instead of jumping the spark plug gap. In this case, it is from the top terminal of the plug to the metal shell down the outside of the 'ceramic' insulator.

This discharge can often leave black markings 'etched' into the insulator over a period of time.

The symptom is caused by a poor connection on to the spark plug top terminal and/or poor sealing of the boot on to the plug.

Check the overall condition of the HT connection (caps/covers/boots/leads) and that they are secure on to the top of the plugs. Ensure the sealing arrangement fits tightly around the ceramic insulator of the spark plugs – sealing effectiveness can reduce through ageing. If flashover has been occurring over a long period (black lines will clearly be seen on the spark plug insulator) the cover may be damaged. Renew deteriorated items as necessary. Make sure components are clean and dry upon assembly.
